Report on fire safety studies in Maitri station and summer huts at Antarctica

K.C. WADHWA

Defence Institute of Fire Research, Brig. S.K, Majumdar Road,
Timarpur, Delhi - 110 054

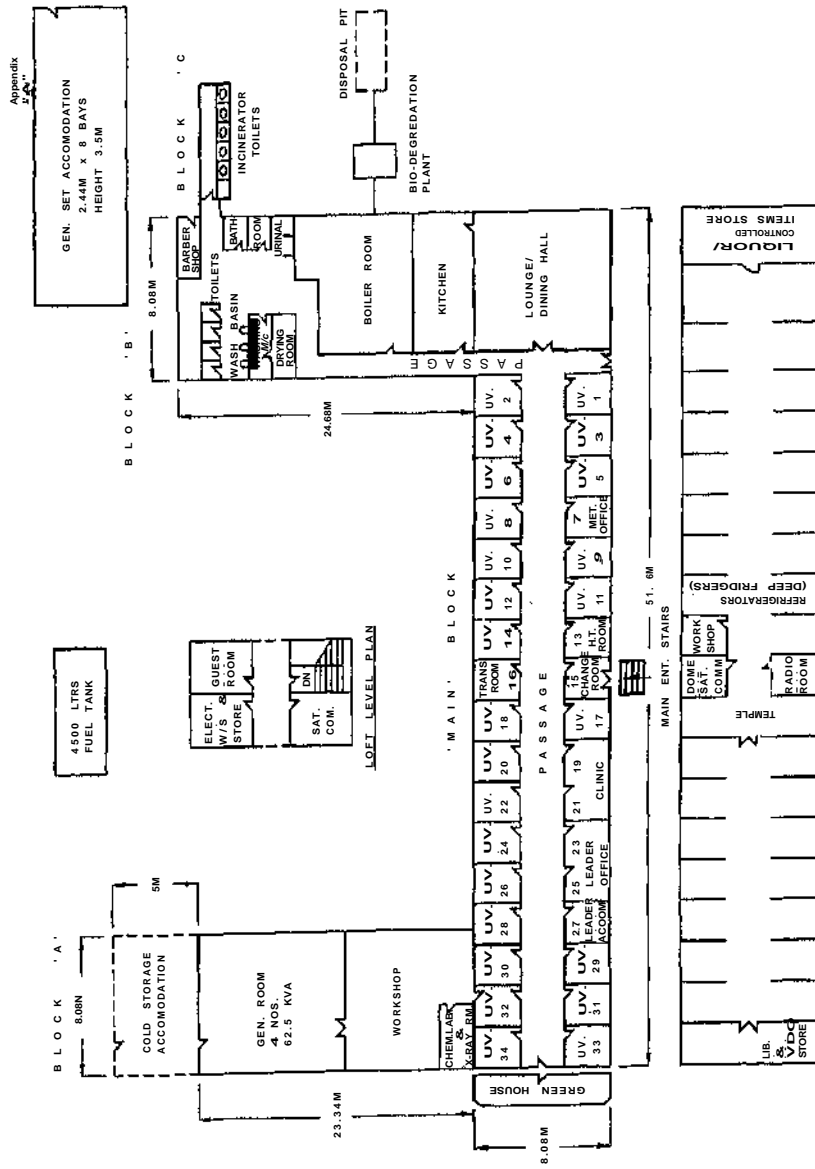
Layout plan of Maitri Station

This permanent station (Appendix "A") presently in use is a compact integral unit encompassing the following modules:

MAIN BLOCK	:	Consisting of living modules, station office, hospital & IMD Lab.
LOFT LEVEL	:	On the top of these living modules used for storage purposes.
BLOCK "A"	:	Presently under renovation and reappropriation as hospital with medical equipment storage area.
BLOCK "B"	:	This accommodates boiler room, kitchen, lounge/dinning hall, bath cubicles & chemical toilets (now storage area).
BLOCK "C"	:	Accommodates 5 Nos. incenerator toilets.

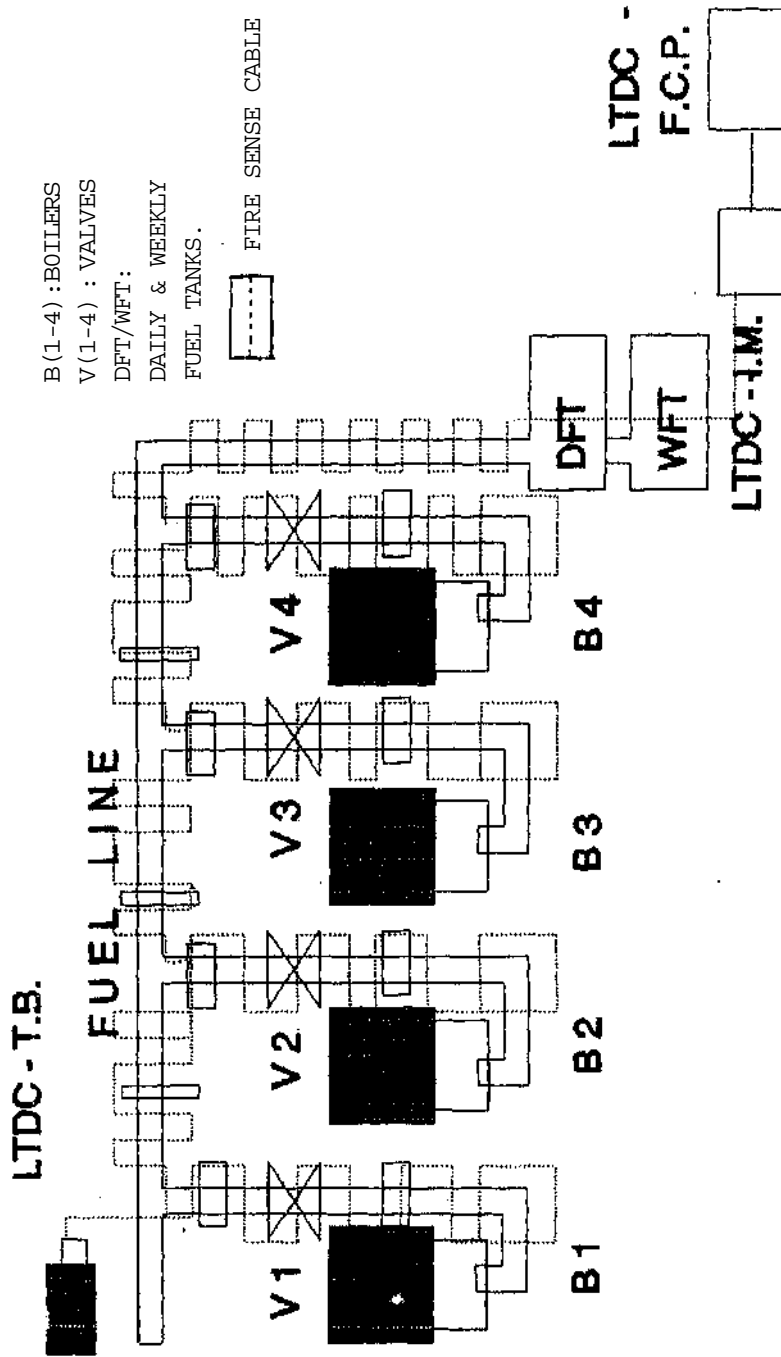
Layout of linear thermal detection cable system

This latest technology in the filed of fire detection comprising fire sense cable, fire control panel, interface module and termination box were installed in the boiler room covering all the four fuel feeding lines to the boilers, daily fuel storage tank(500 ltrs.) and weekly fuel storage tank(2500 ltrs) . Fire sensing wire, interfce module and termination box were installed in the boiler room while

the fire control panel and hooter in the lounge/dinning hall keeping in view the presence of members round the clock in this area(appendix "B")

Any rise in temperature/heat generation in the boiler room would activate the fire sense cable which through interface module would transfer audio-visual signals to fire control panel, thus actuating the hooter for the turnout of the members to attend the call. The microprocessor based key board operating the panel/hooter would have to be brought into silence only by pressing four digit secret number known to the authorised persons only after attending the fault in the boiler room.

To maintain the efficacy of the system and to avoid the false alarms the following points must be strictly adhered to:-

- i. To charge maintenance free batteries supplying 24V DC to the interface module once in a week.
- ii. To reset the fire control panel immediately after the disruption of AC supply feeding it.
- iii. Only authorised person to handle and maintain this modern detection cum-alarm system.
